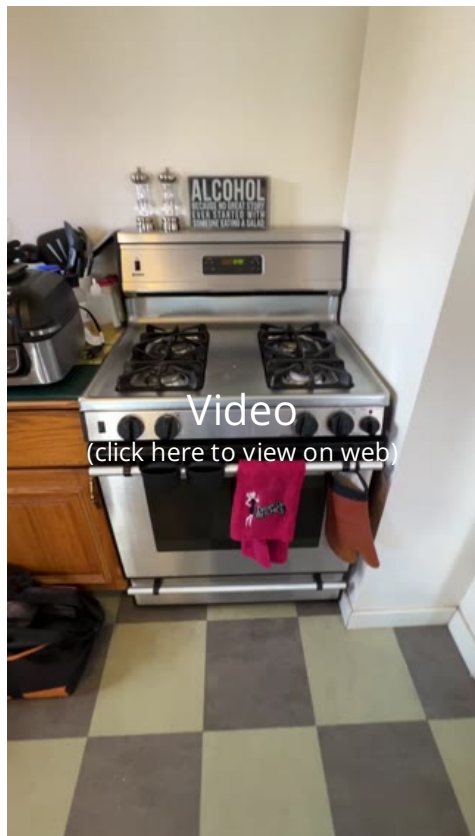
3.1.1 Range/Oven/Cooktop

Range was not fastened to the floor. This poses a safety hazard to children. Recommend a qualified professional secure range to the floor or wall so it can't tip over.

Contact a qualified professional.

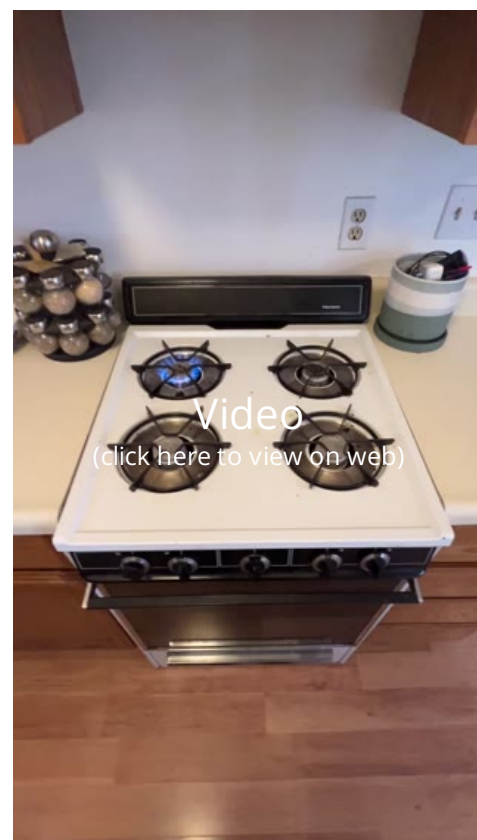
3.1.2 Range/Oven/Cooktop

**BURNER NOT LIGHTING**

One or more heating elements did not heat up when turned on. Recommend qualified professional evaluate & repair.

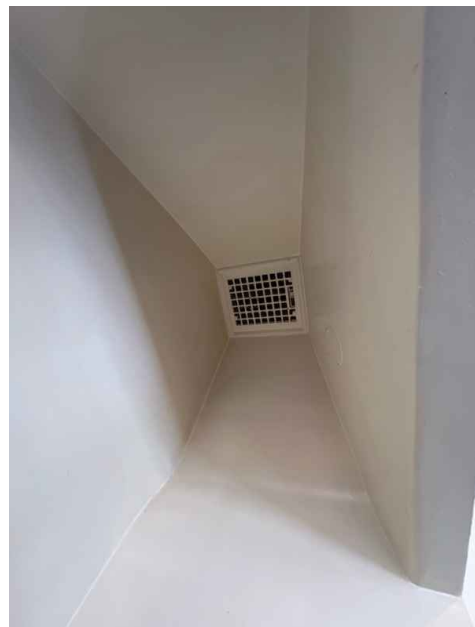
3.1.3 Range/Oven/Cooktop

**EXHAUST FAN INOPERABLE**

Exhaust fan was inoperable at time of inspection. Recommend a qualified contractor repair.

Contact a qualified professional.

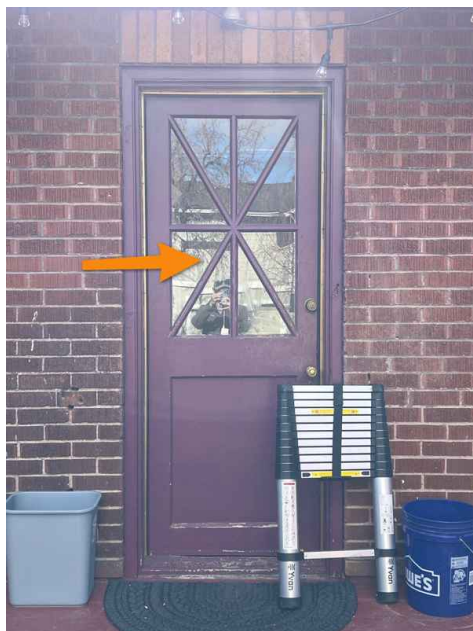
9.2.1 Exterior Window & Doors

**NON TEMPERED GLASS**

Contact a qualified professional.
